## **Interim Report**

### ***Conservation of the Northern Surrounding Walls (Phase2) - Project BF14/07***

**BUTRINT HERITAGE CENTRE**

### ***Conservation of the northern surrounding walls: from the Lake Gate to Western Gate (Phase2)***

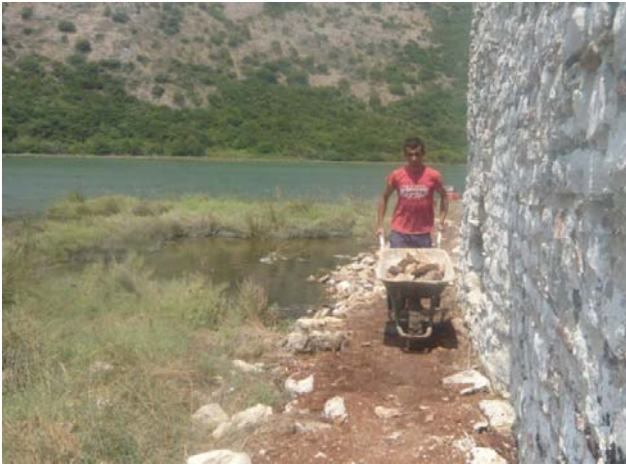
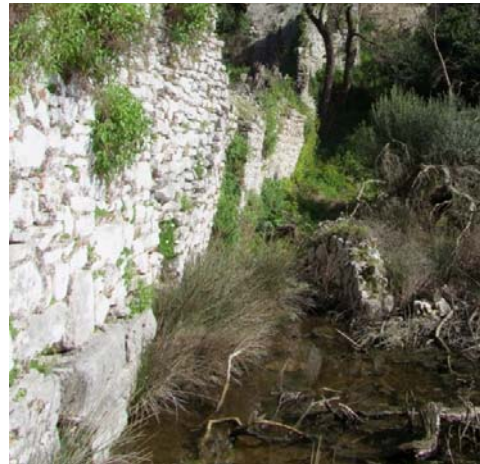
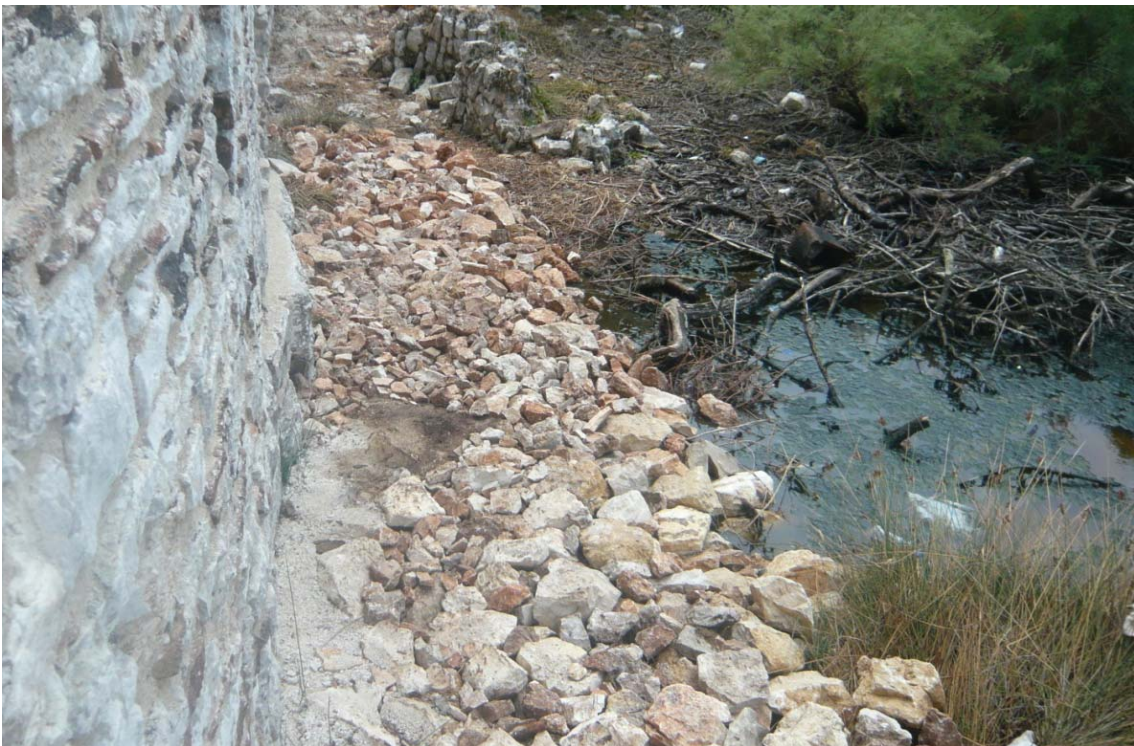
Because of the unstable terrain which is caused due to the proximity with the wetland it was continued the backfilling of the area beside the water in a width of about 1.5 meters in the western side of the wall. This not only creates a stable terrain and stops water erosion but also serves as base platform for scaffolding and enabled access for conservation workmen. The rock materials were collected along the excavated sections of the road from Ksamili and were transported to the spur wall with the support of the floating platform that was build some years ago.

**Backfilling of the ponds and continuation of the platform in sections 8.ga – 8.fa**

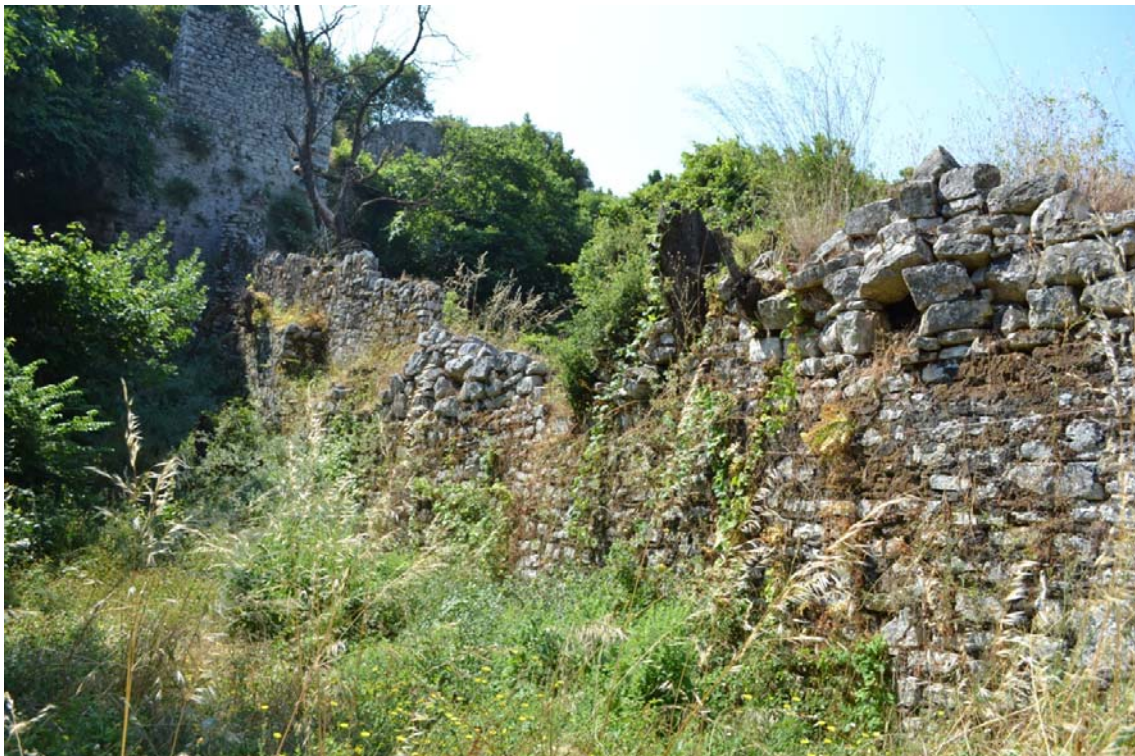
**Closing wall sections 8f – 8a showing the dense vegetation before the intervention**

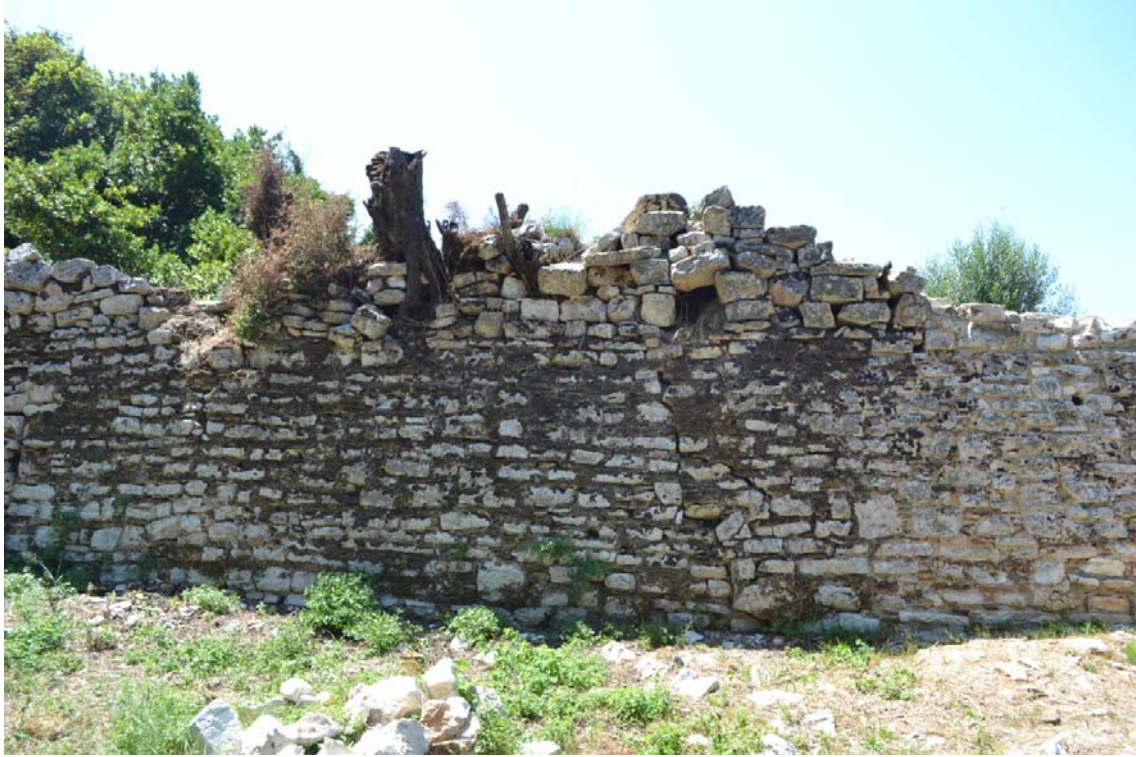
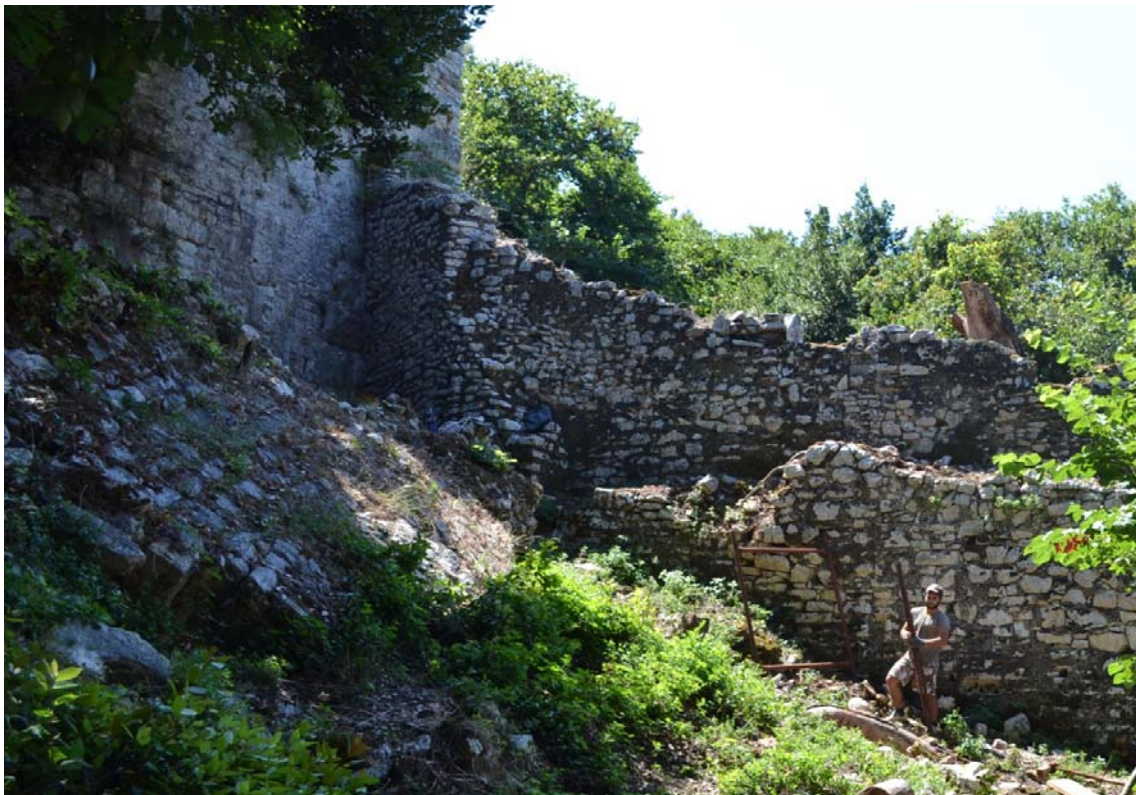
**Closing wall (sections 8f – 8e above and 8d – 8a below) after the intervention for vegetation clearance**

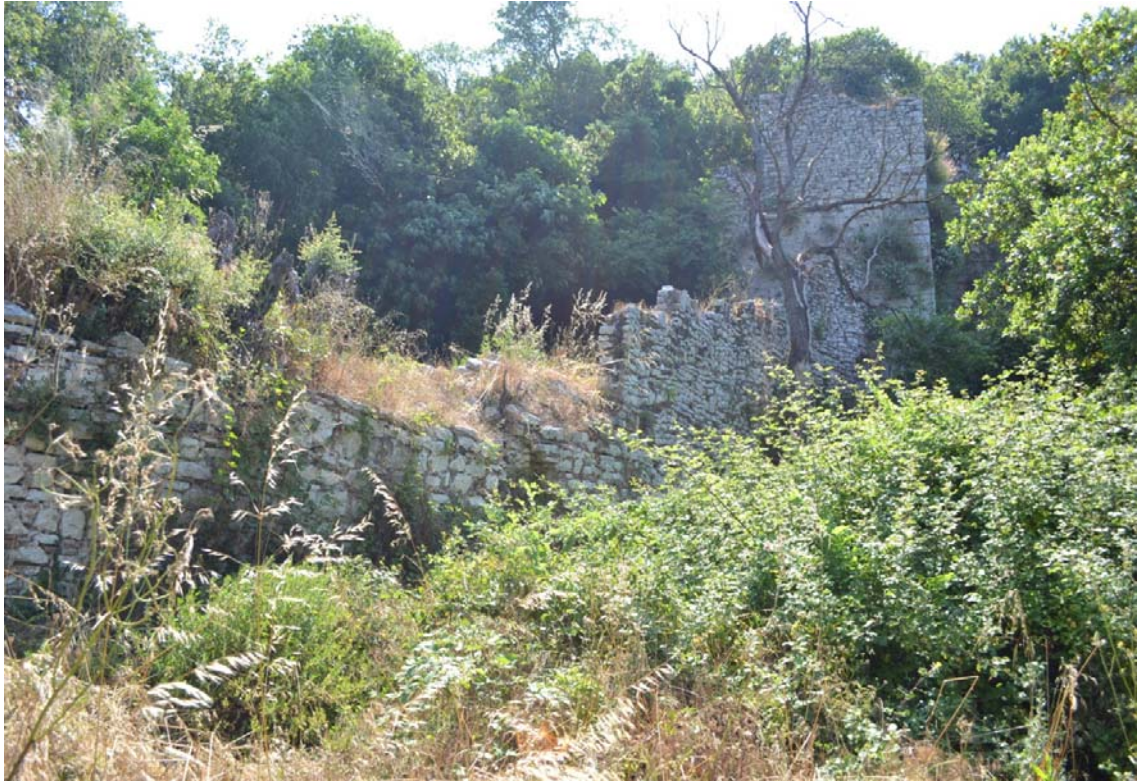
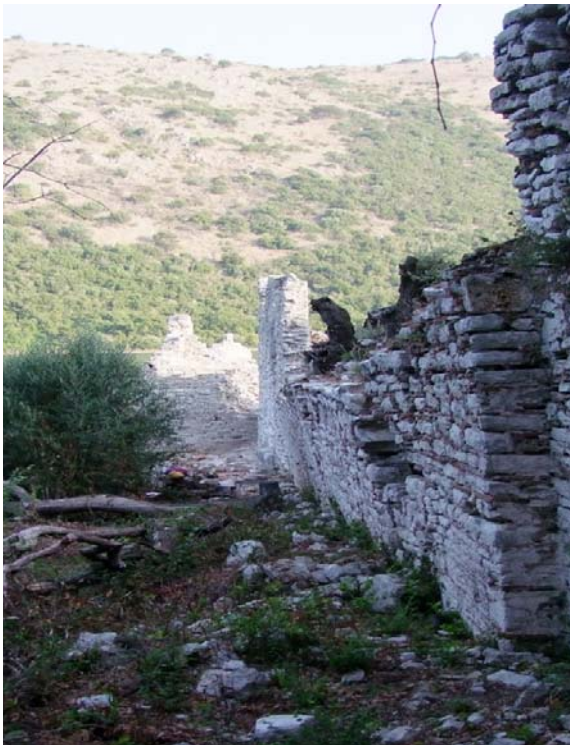
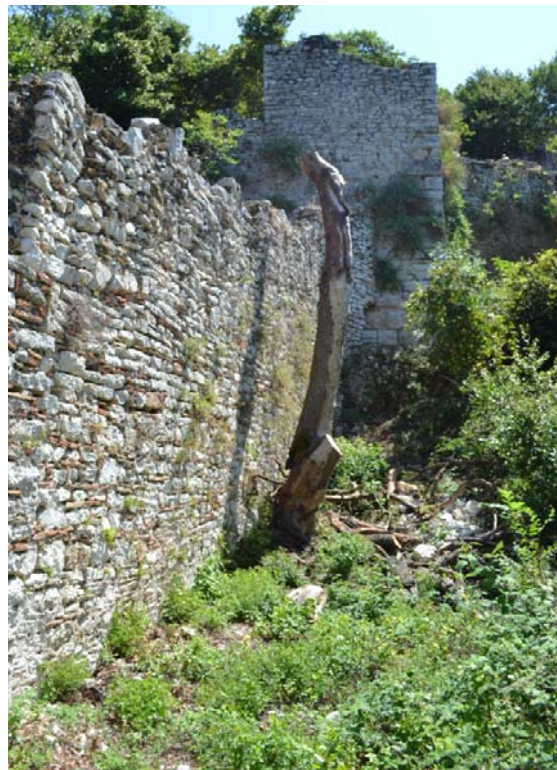
**Closing wall sections 8fa – 8aa before and after the vegetation**

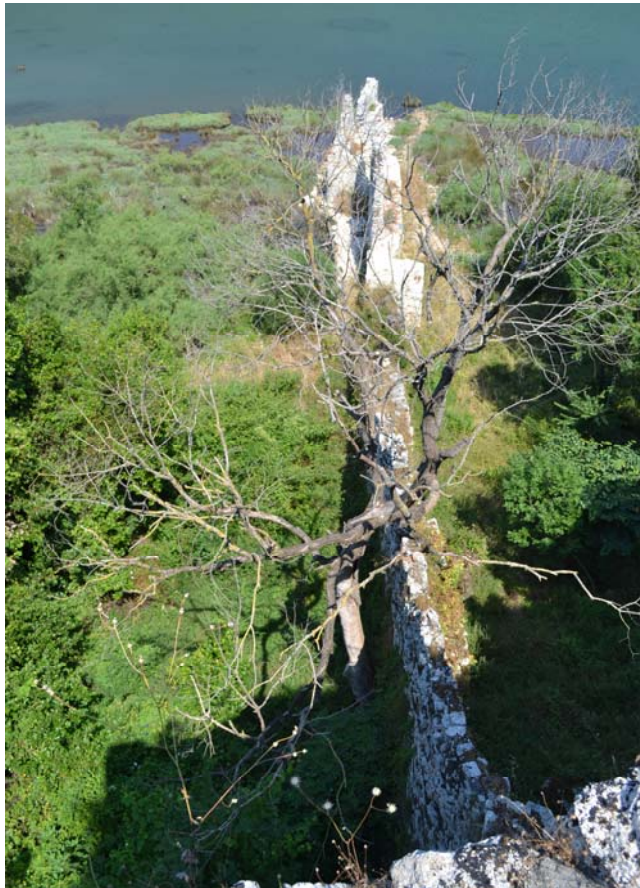
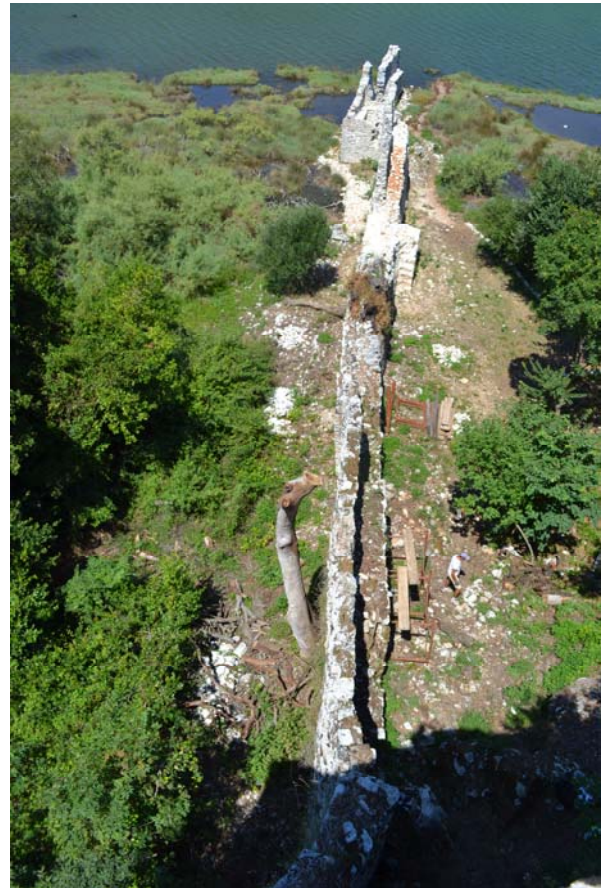
The structure of the closing wall was seriously endangered by a dead elm tree that was hanging just above the tallest section of the wall with a diameter of branches that covered more than 7 meters in the length of the wall. This tree was reported in 2007 to show symptoms of the Dutch elm disease and in 2009 was totally dried. The branches and the roots had started to degrade increasing risk of falling on the wall structure and causing collapse of the sections. As well the degrading roots had lost anchoring strength, making the tree swinging from the wall and causing vibrations on the wall structure that lead to several cracks and increasing risk for collapse.

**Dead elm tree on the closing wall before and after intervention**

The task for removing the tree was very difficult as most of the tree branches were above the wall and the isolated area required a lot of work for transportation of the scaffolding and the materials. To avoid any damages of the wall structure from undesired falling of branches, the wall structure was previously secured with scaffolding. After that the branches were cut individually and in small sections. The tree was cut to the wall level as the remaining trunk presents no danger for the structure and it can serve for supporting the scaffolding for the consolidation works.

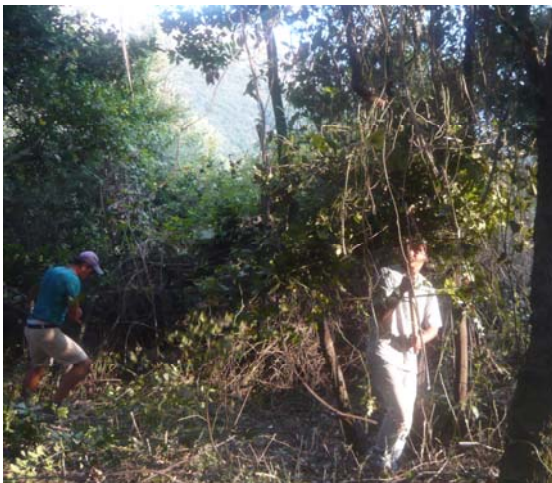
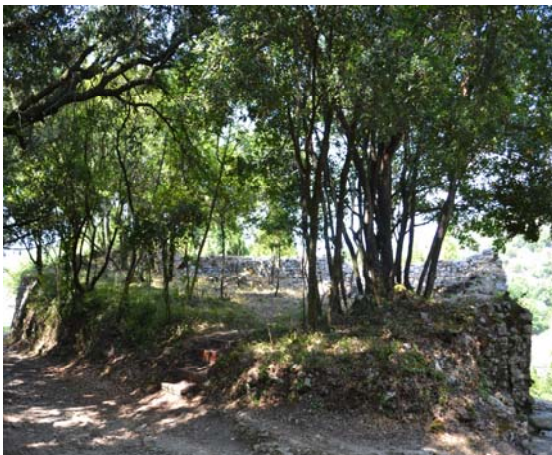
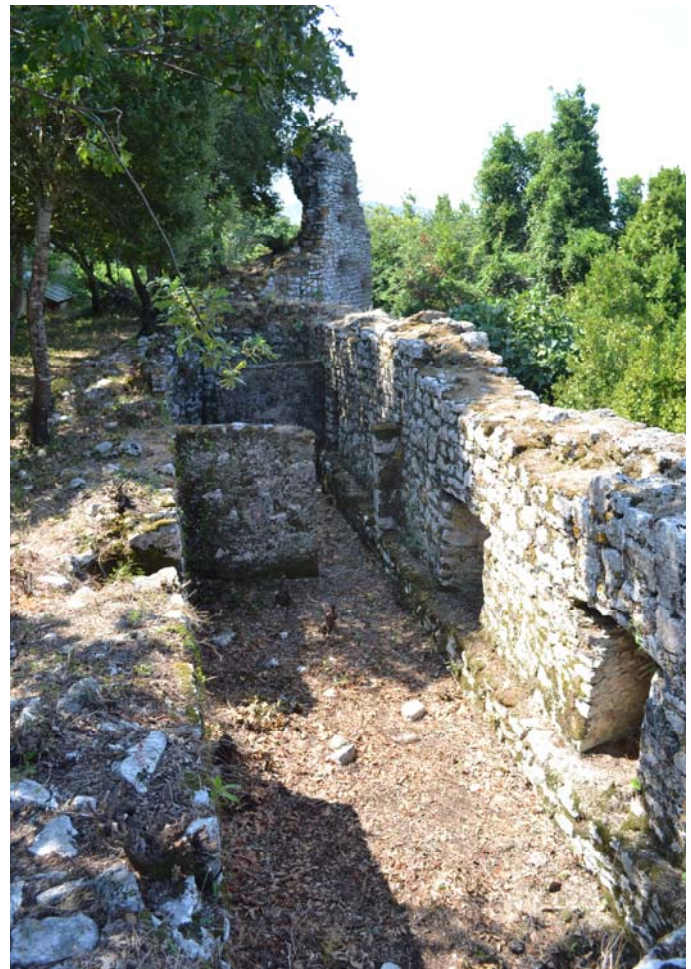
**Vegetation clearance near the western gate exposing the battlements and fireloops and creating a new panoramic viewpoint.**

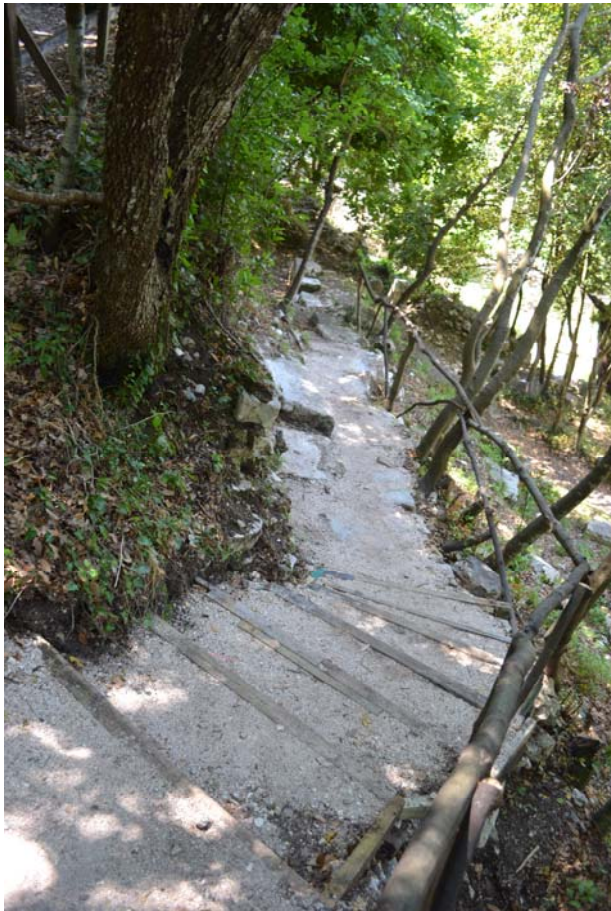
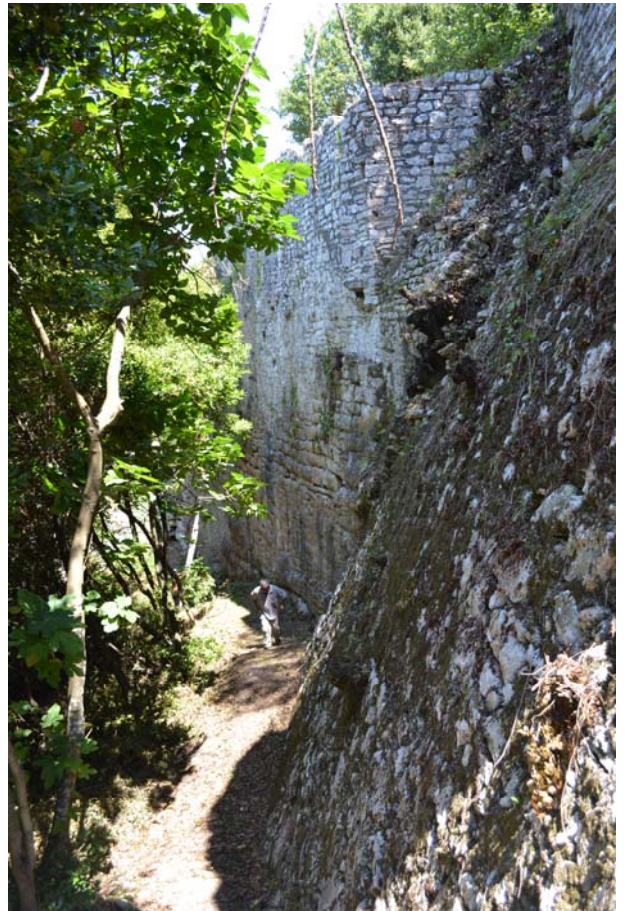
**Improvement of visitors access and creation of new trail**
