CLEANING & REPAIR
OF HISTORIC
STONE & PLASTER

Report on completion of BF Grant Funded project : BF13/15 - Placing of telltales across structural cracks within Butrint and extramurally (Triangular Fortress and Ali Pasha's Castle)

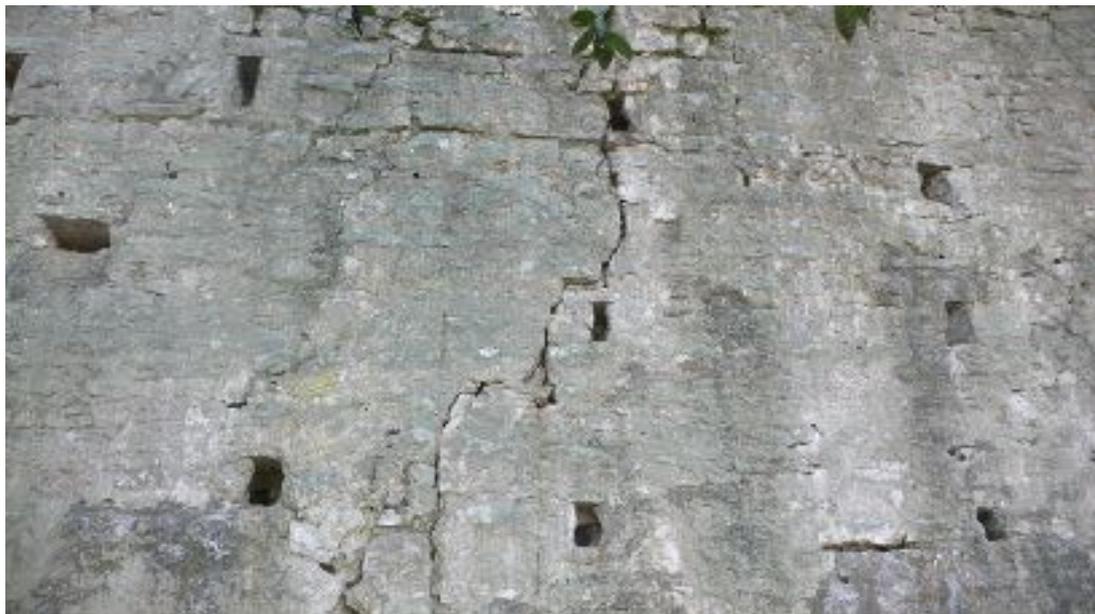
Fig 2. Crack in wall from Lake Gate to Lion Gate possibly caused by pressure of supported earth potentially worsened after periods of heavy rainfall.

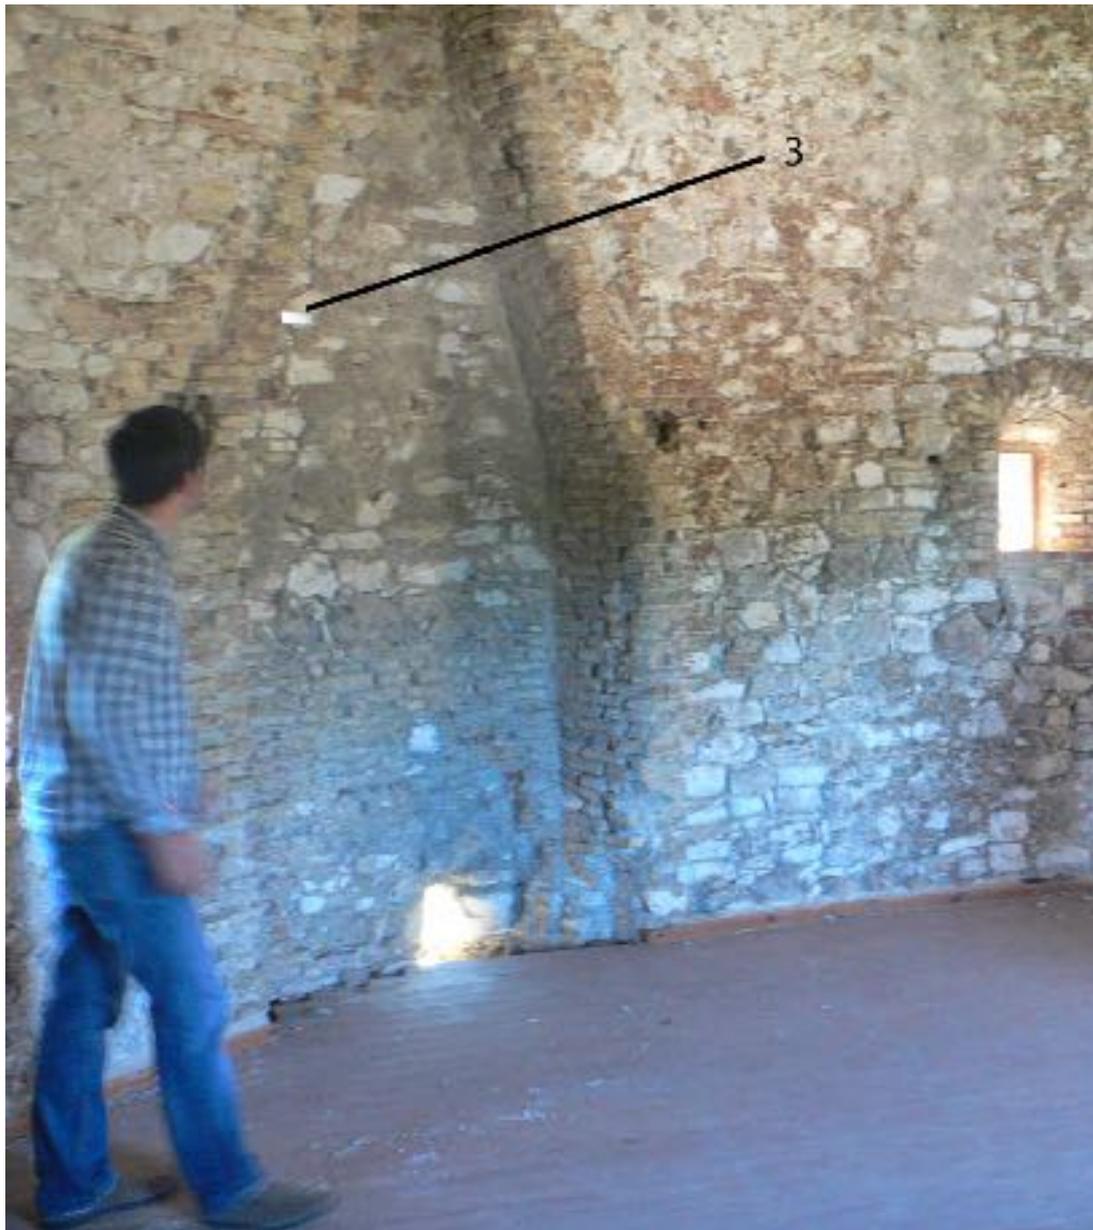
Fig 3: Telltale fixed to interior of Triangular Fortress South East Tower.

The last part of the day was devoted to placing telltales in 3 positions on the Triangular Fortress. (See record sheets 1-3)

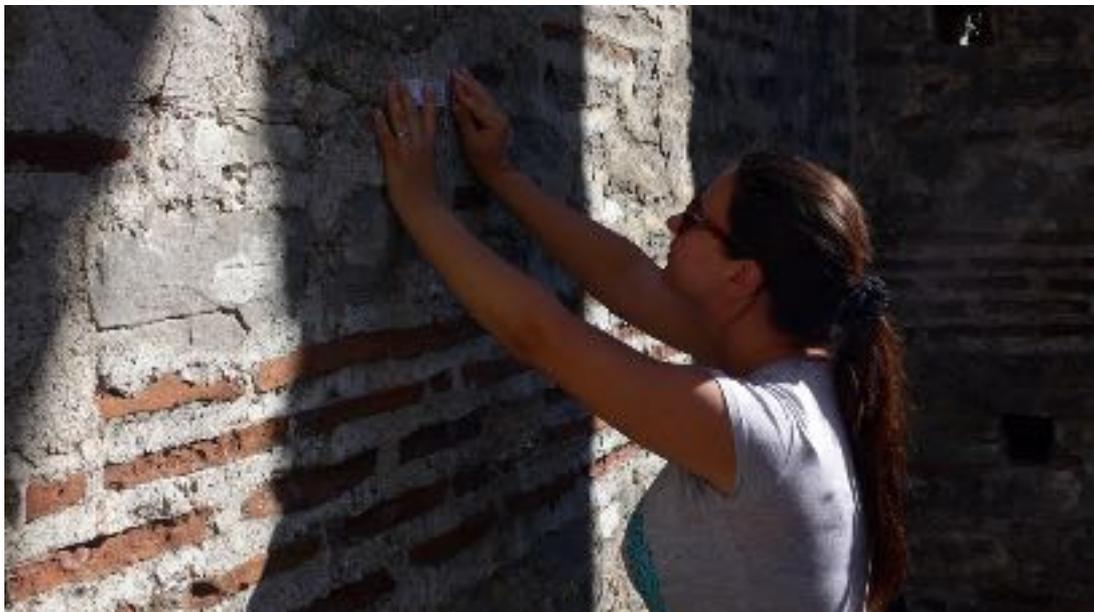
Fig 4. Valbona Hysa affixes a telltale to an internal wall in the Great Basilica

The second day was devoted to the placing of telltales within Butrint at sites chosen through discussion with the group. 14 different sites were chosen ranging in scope from cracks in individual Hellenistic era stones to large iron cramp induced cracks in the masonry of the Lion Gate. Each was recorded photographically and members of the group took turns in fixing the telltales in place. (See record sheets 4 to 18)

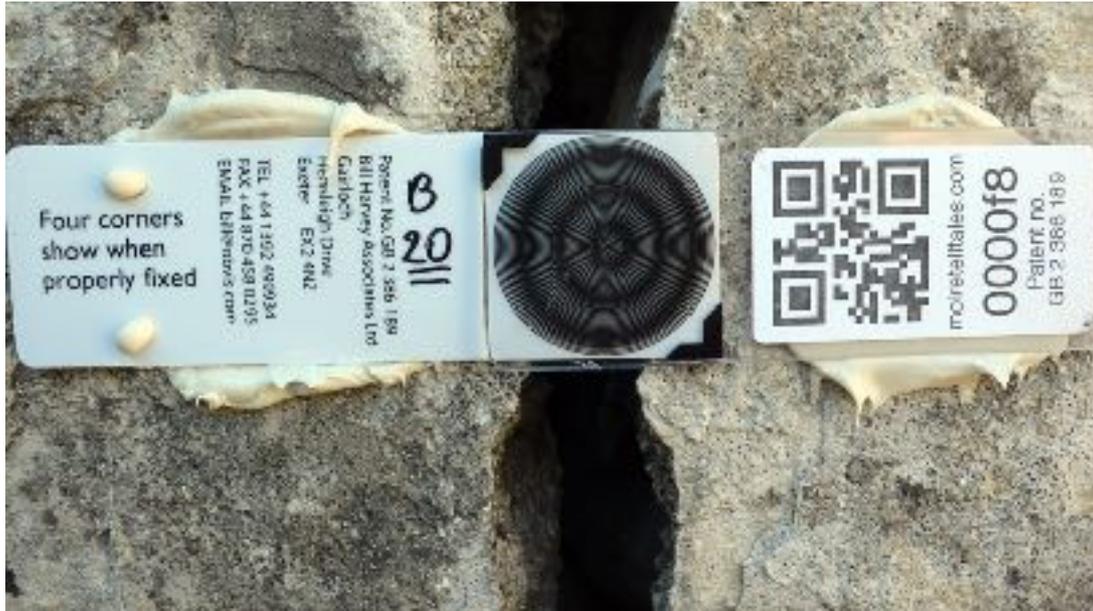
Fig 5. A Moiré telltale in position

Moiré telltale made by Bill Harvey Associates (<http://www.moiretelltale.com/>).
